OAK RIDGE NATIONAL LABORATORY
Operated by
UNION CARBIDE NUCLEAR COMPANY
Division of Union Carbide Corporation

ORNL
CENTRAL FILES NUMBER
58-11-44

DATE: November 17, 1958
SUBJECT: Fallout from 3505 Metal-Recovery Stock
on Malan Contractor's Area, Jan. 17, 1956.
TO:
FROM: W. W. Ogg

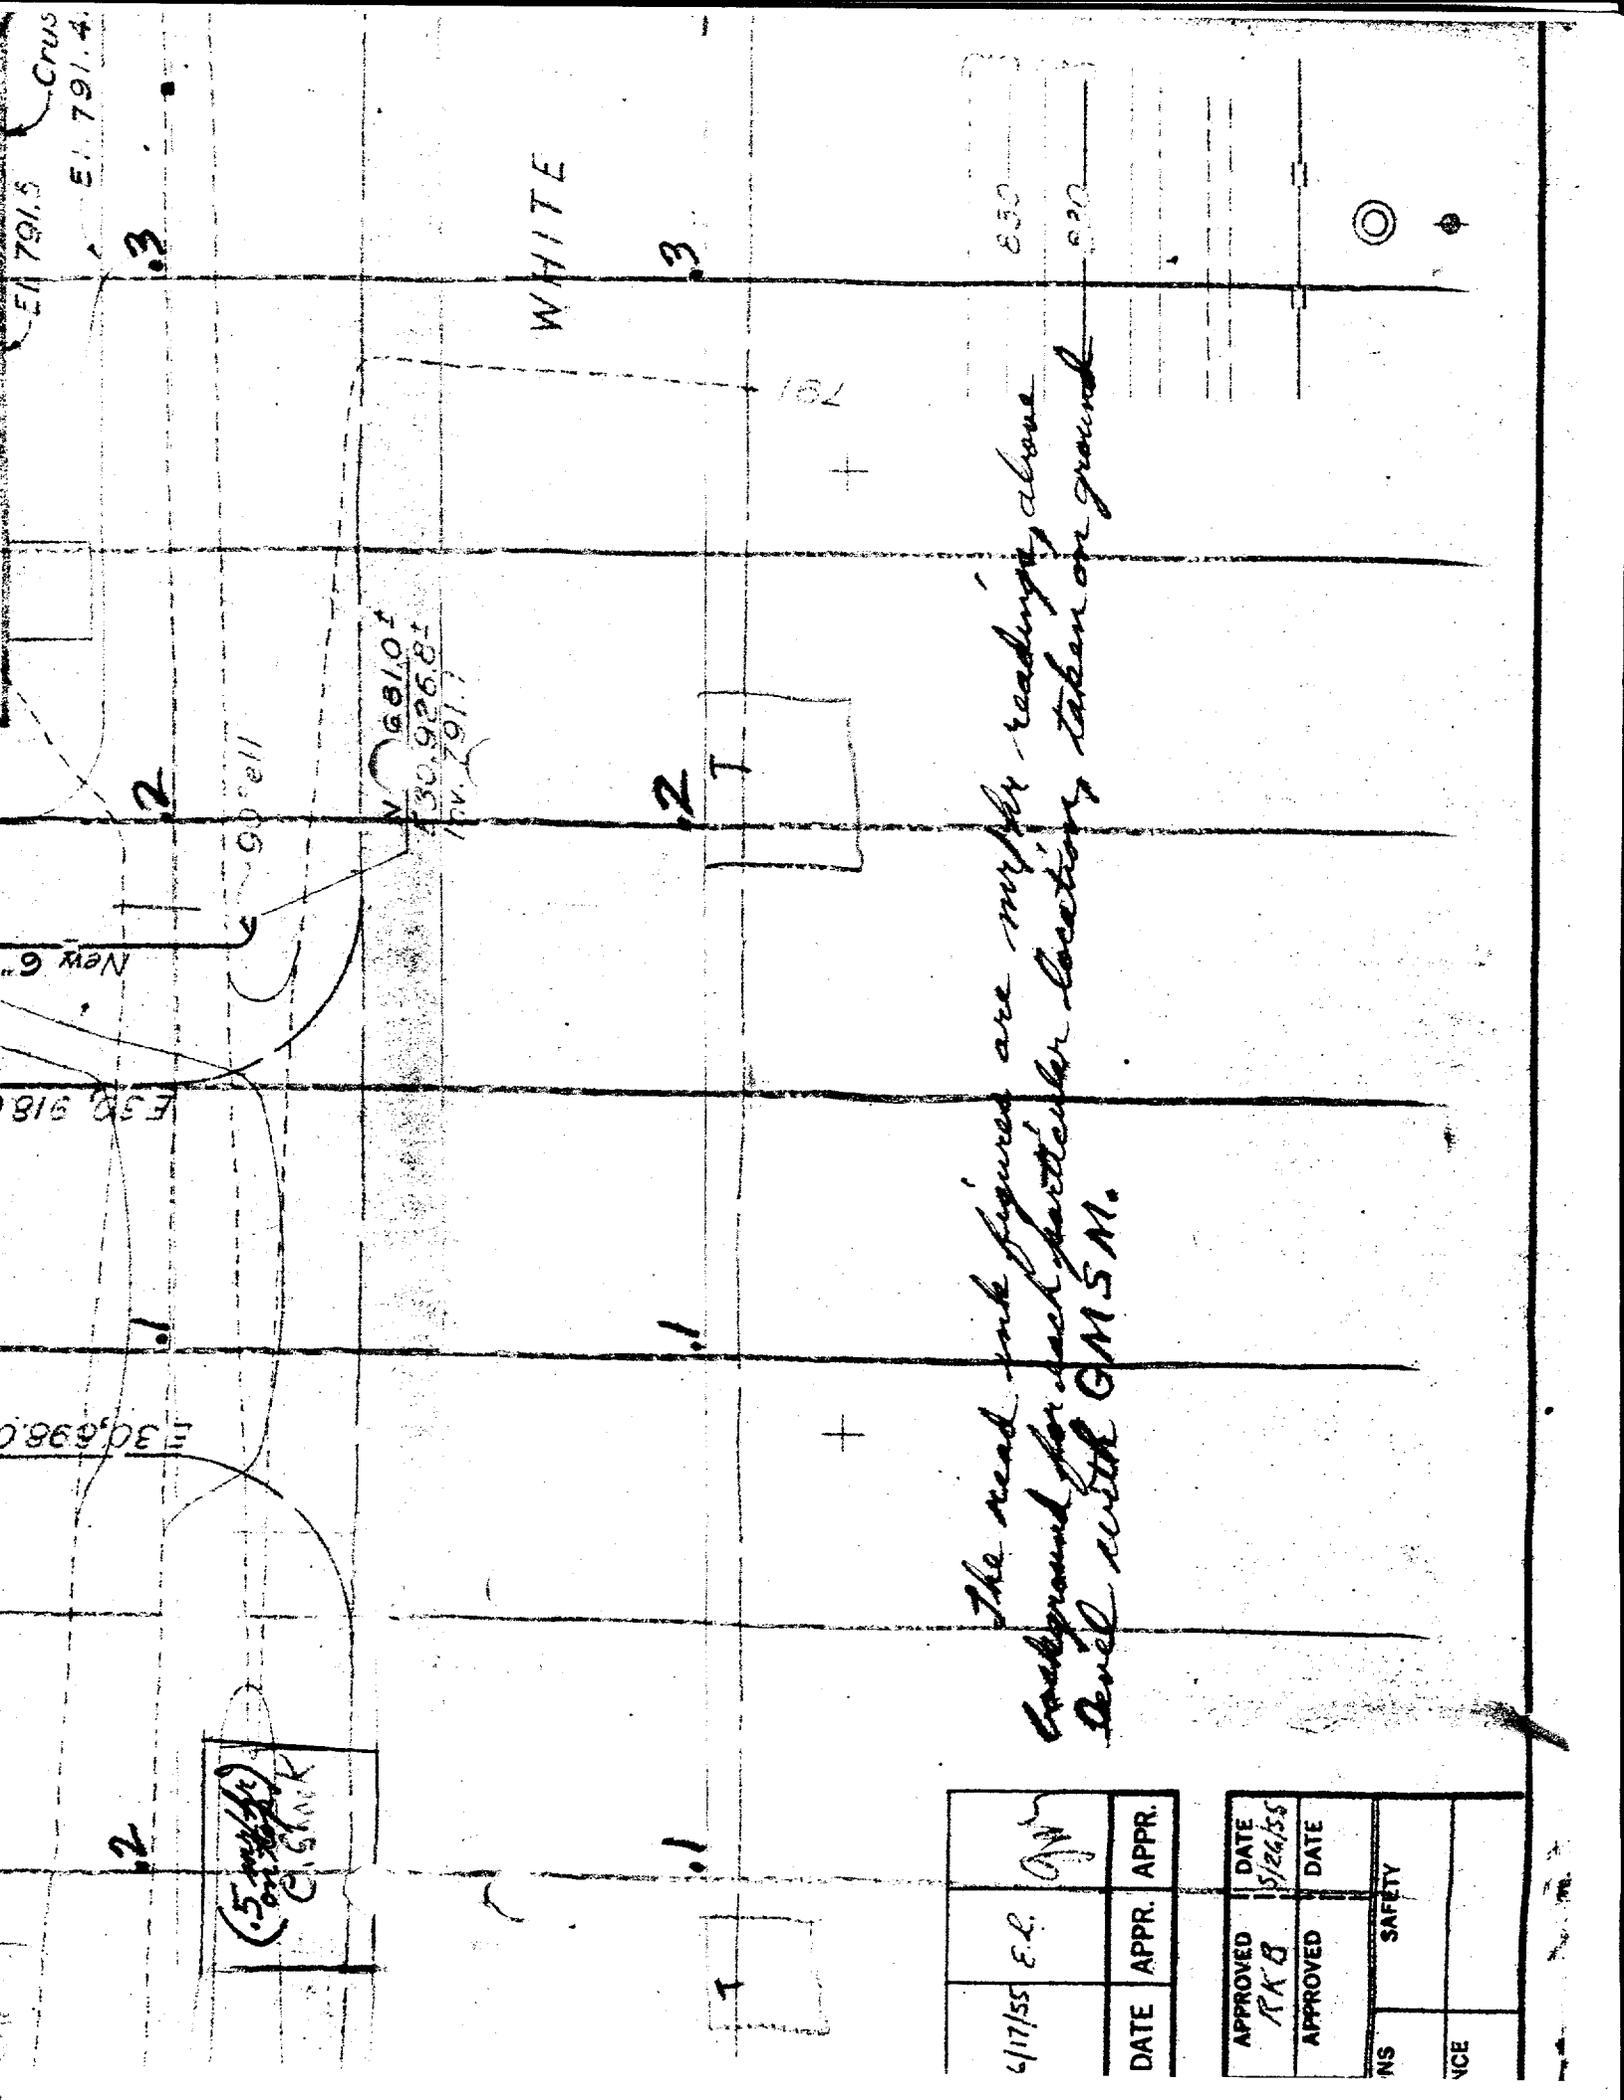
The read ink figures are my Mr readings above background for each particular location taken on ground level with GMSM.

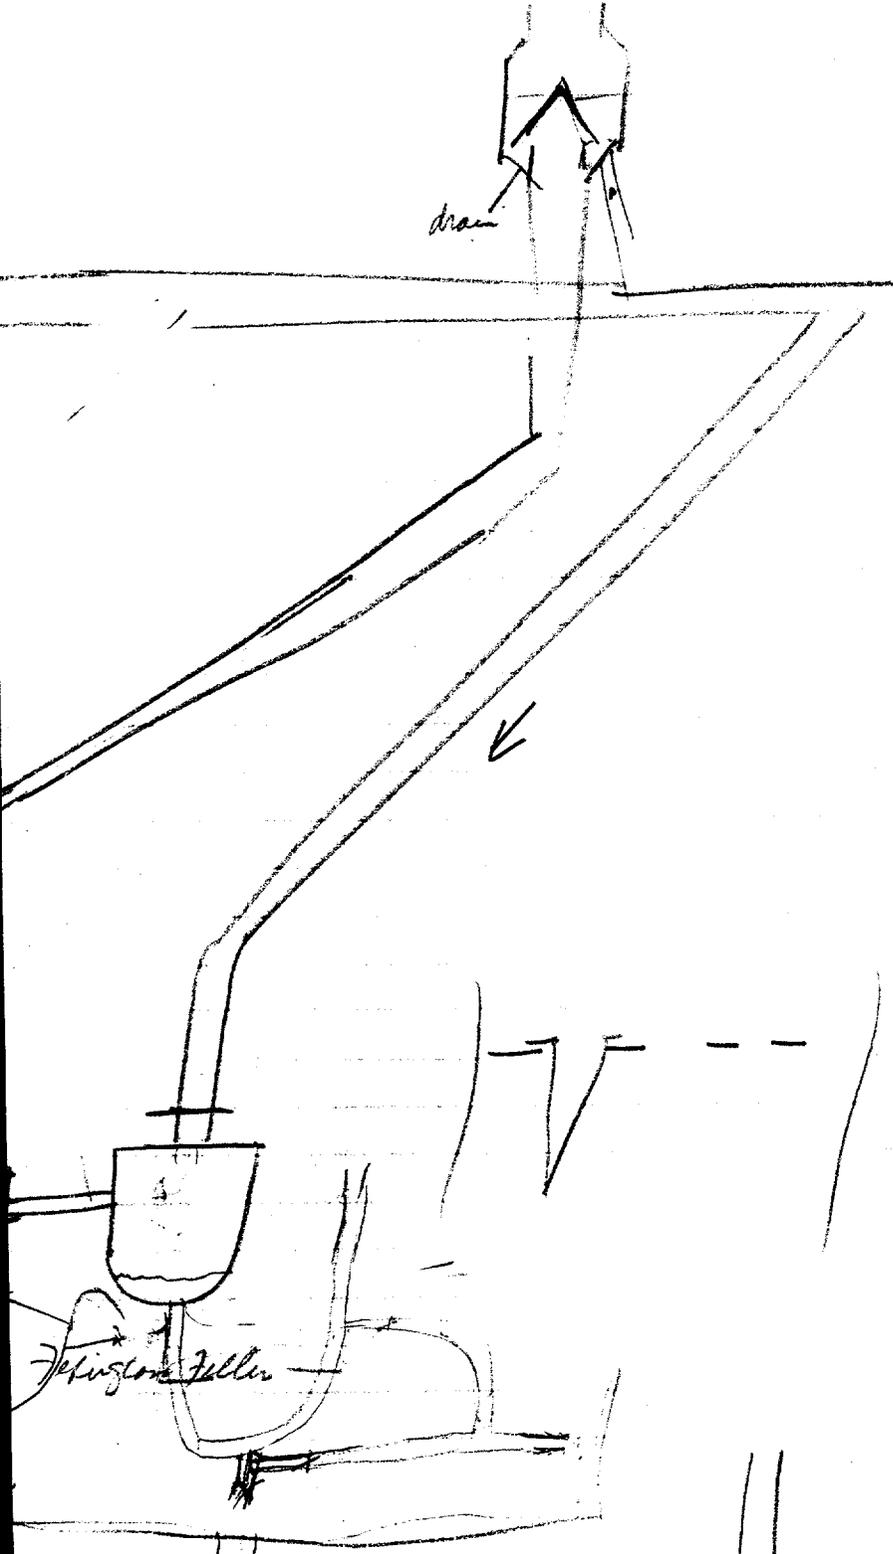
Est 2500cfm
reducing vacuum from
6" H₂O

Set to
W-6 - 6 AM daily

NOV. 1 - Hat put on
stock

Normal air
activity in control
room of 3505
